Report of	Meeting	Date
Director (Commercial Services) (Introduced by Executive Member (Resources))	Executive Cabinet	Thursday, 14 July 2022

## Approval to go out to tender for remedial repairs to Brinscall Pool concrete floors

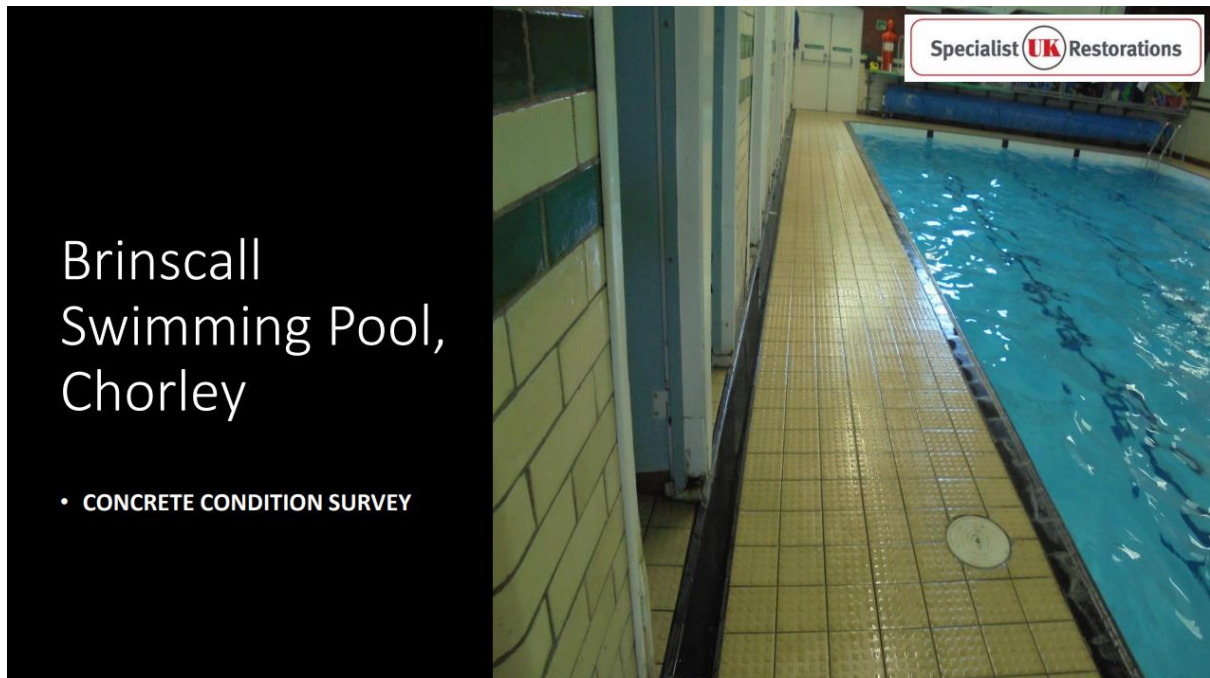
Brinscall  
Swimming Pool,  
Chorley

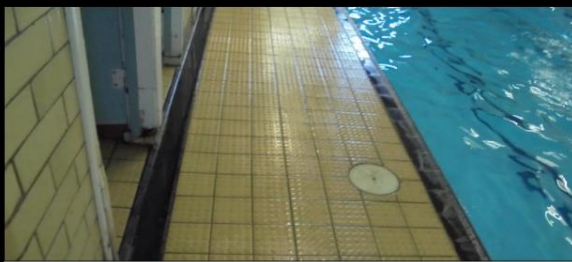
Pool walkway is not water tight allowing ingress to concrete floor slabs and supporting columns and beams below.

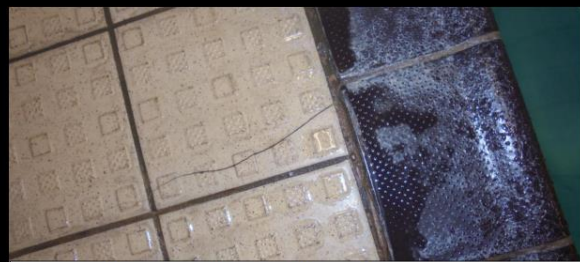
Close up of hairline cracking to walkway tiles which we noted in various areas around pool.

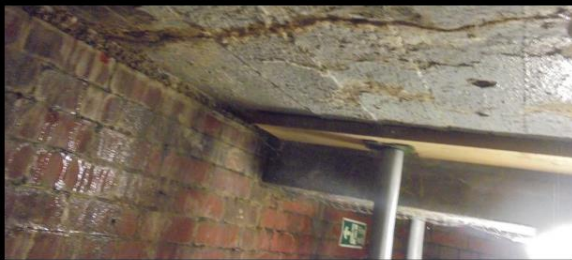
Cracking to below concrete soffit with water droplets appearing on surface, evidence of continuous water ingress.

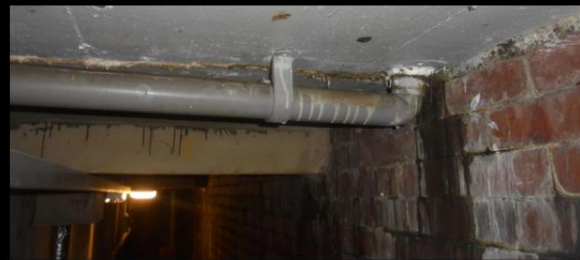
Further image of cracking to walkway concrete soffit.

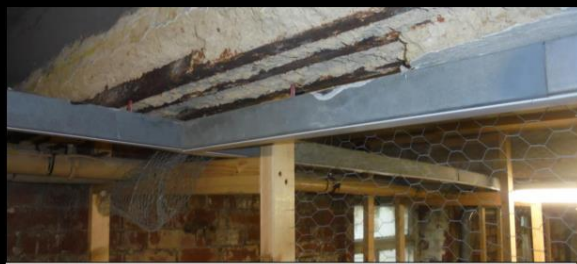
Large area of concrete spalled from structural beams showing eroded steel reinforcements.

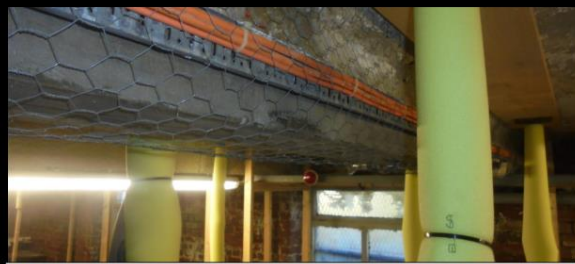
Wire mesh used as a safety measure preventing spalled material falling from concrete beams.

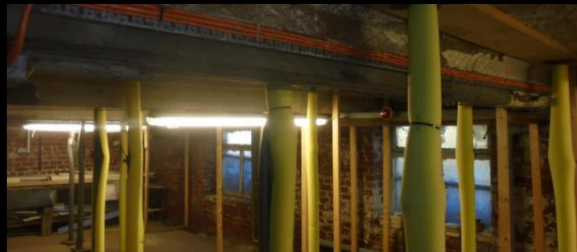
Previous repairs on beams have failed due to the continuous rusting and expanding of steel reinforcements.

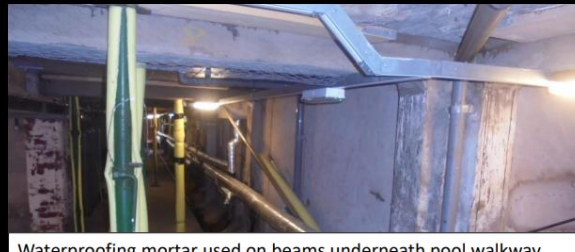
Waterproofing mortar used on beams underneath pool walkway this is containing water from above accelerating the deterioration of concrete material and steel reinforcements

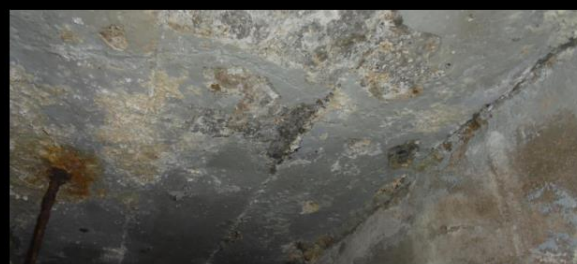
Hammer test revealed large areas of the concrete soffit which are hollow with evidence of continuous water ingress from above.

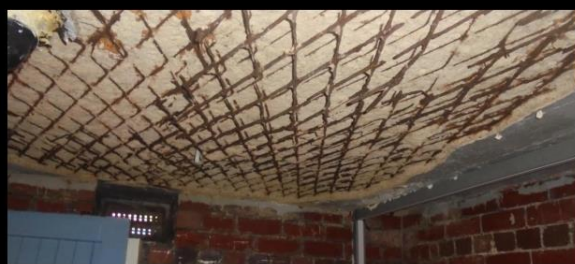
Large area of concrete soffit spalled whilst hammer testing. Spalling caused by erosion of steel mesh reinforcement.

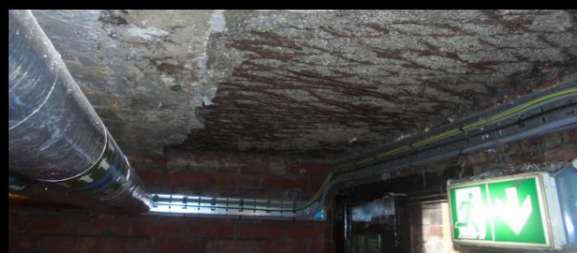
Further example of spalled concrete caused by erosion of mesh reinforcement.

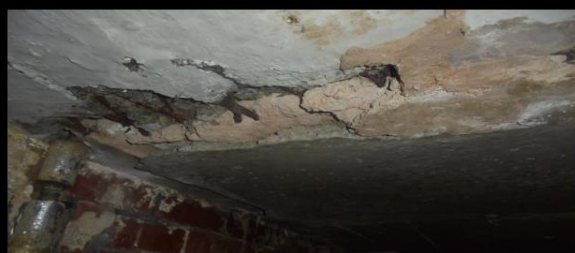
Previous repair attempted using sand cement repair which has failed revealing rusted steel reinforcements

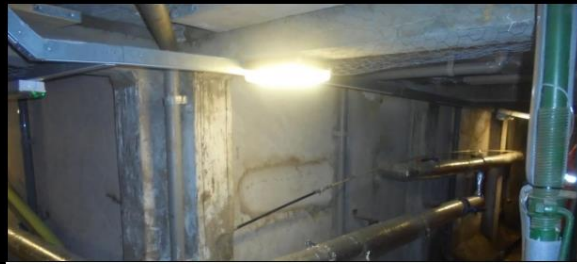
Pool walls and columns have been previously tanked but survey has revealed the system has failed with large sections sounding hollow and there is evidence that water is penetrating through.

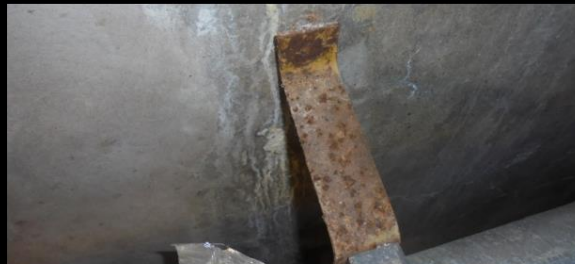
Services have been fixed into tanked pool wall allowing water to penetrate through in places

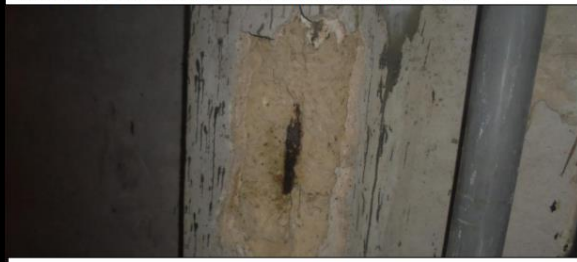
Structural column reinforcement has become eroded causing concrete material to spall along with surface render

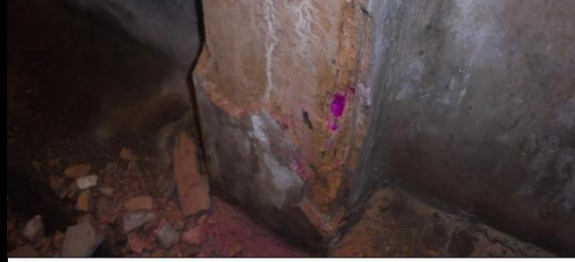
Another example of spalled render to the columns with signs of water penetrating through.

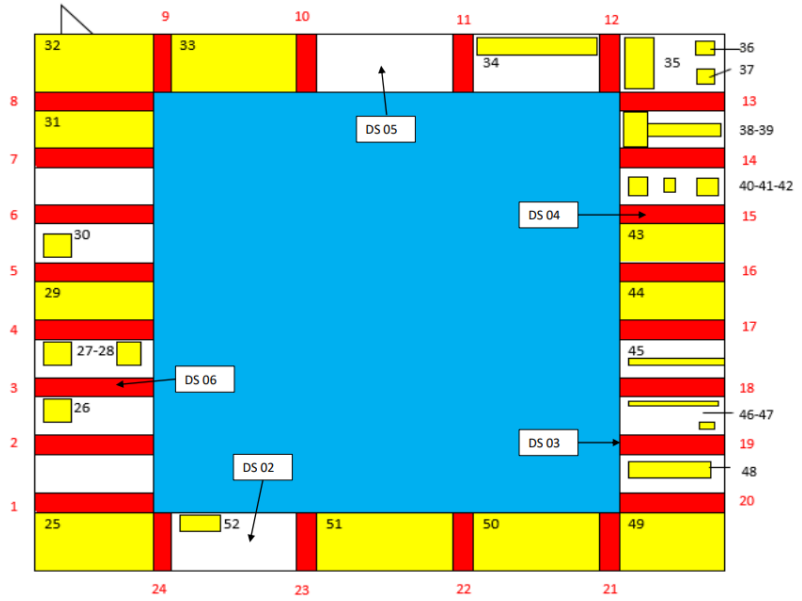
**Basement**  
 Side Room Soffit and Beam  
 Concrete Repairs

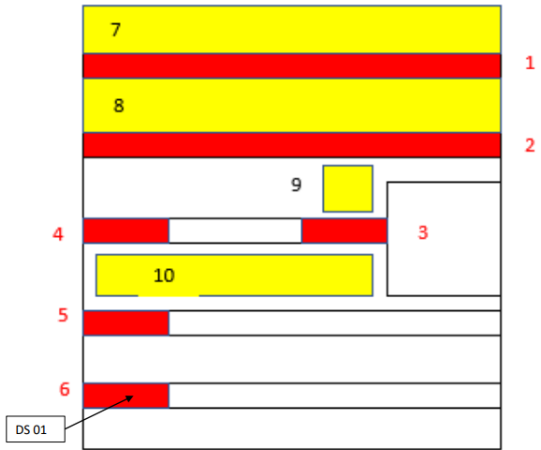
# Appendix D: Temporary Propping
