PROPOSED

Application Number:
 06/00449/FUL
 06/00450/LBC

Agenda Item No.
 B.1 and B.2

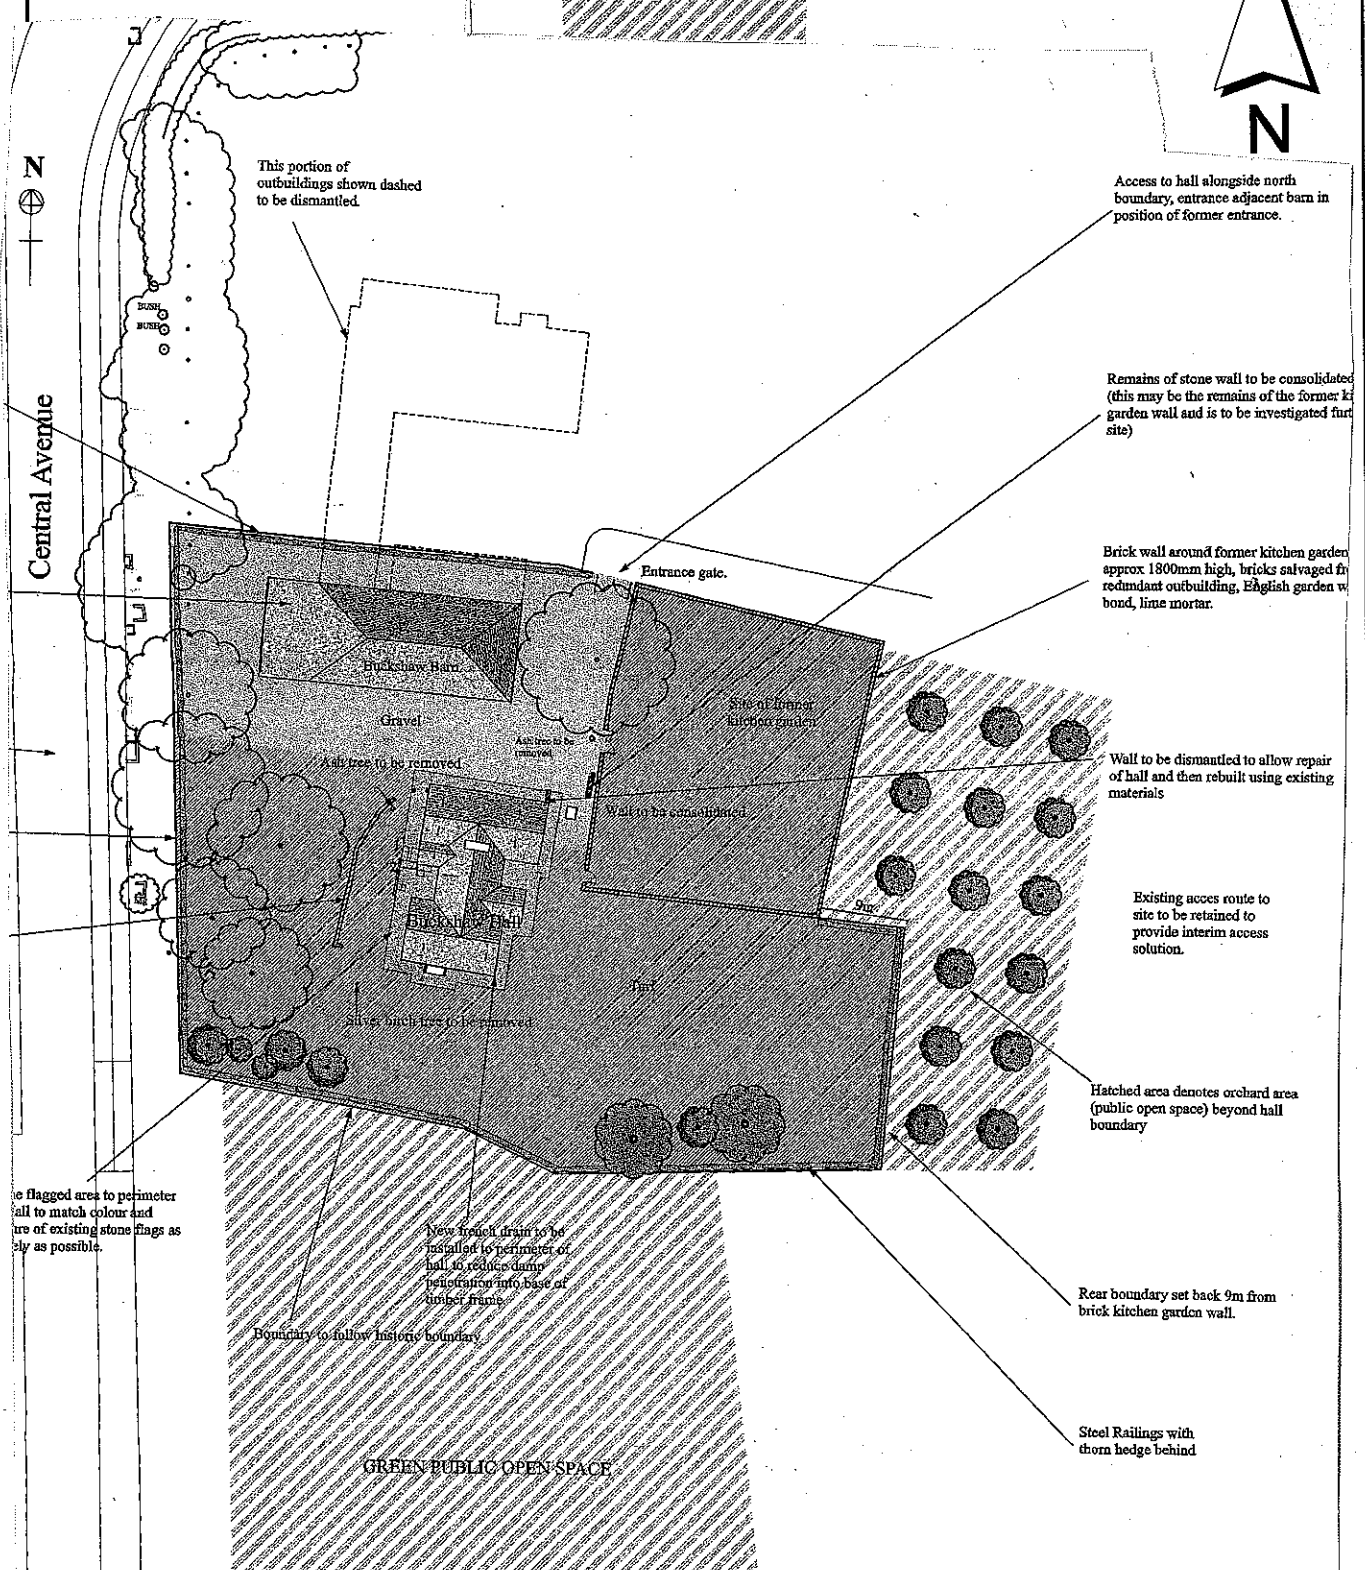
This portion of outbuildings shown dashed to be dismantled.

Access to hall alongside north boundary, entrance adjacent barn in position of former entrance.

Remains of stone wall to be consolidated (this may be the remains of the former kitchen garden wall and is to be investigated further on site)

Brick wall around former kitchen garden approx 1800mm high, bricks salvaged from redundant outbuilding, English garden wall bond, lime mortar.

Wall to be dismantled to allow repair of hall and then rebuilt using existing materials

Existing access route to site to be retained to provide interim access solution.

Hatched area denotes orchard area (public open space) beyond hall boundary

Rear boundary set back 9m from brick kitchen garden wall.

Steel Railings with thorn hedge behind

Flagged area to perimeter wall to match colour and texture of existing stone flags as far as possible.

New French drain to be installed to perimeter of hall to reduce damp penetration into base of timber frame.

Boundary to follow historic boundary
