CROSTON FRMS DETAILED DESIGN

FIGURE 7.4
SHEET 4
PHOTOMONTAGE D

497849/600/019

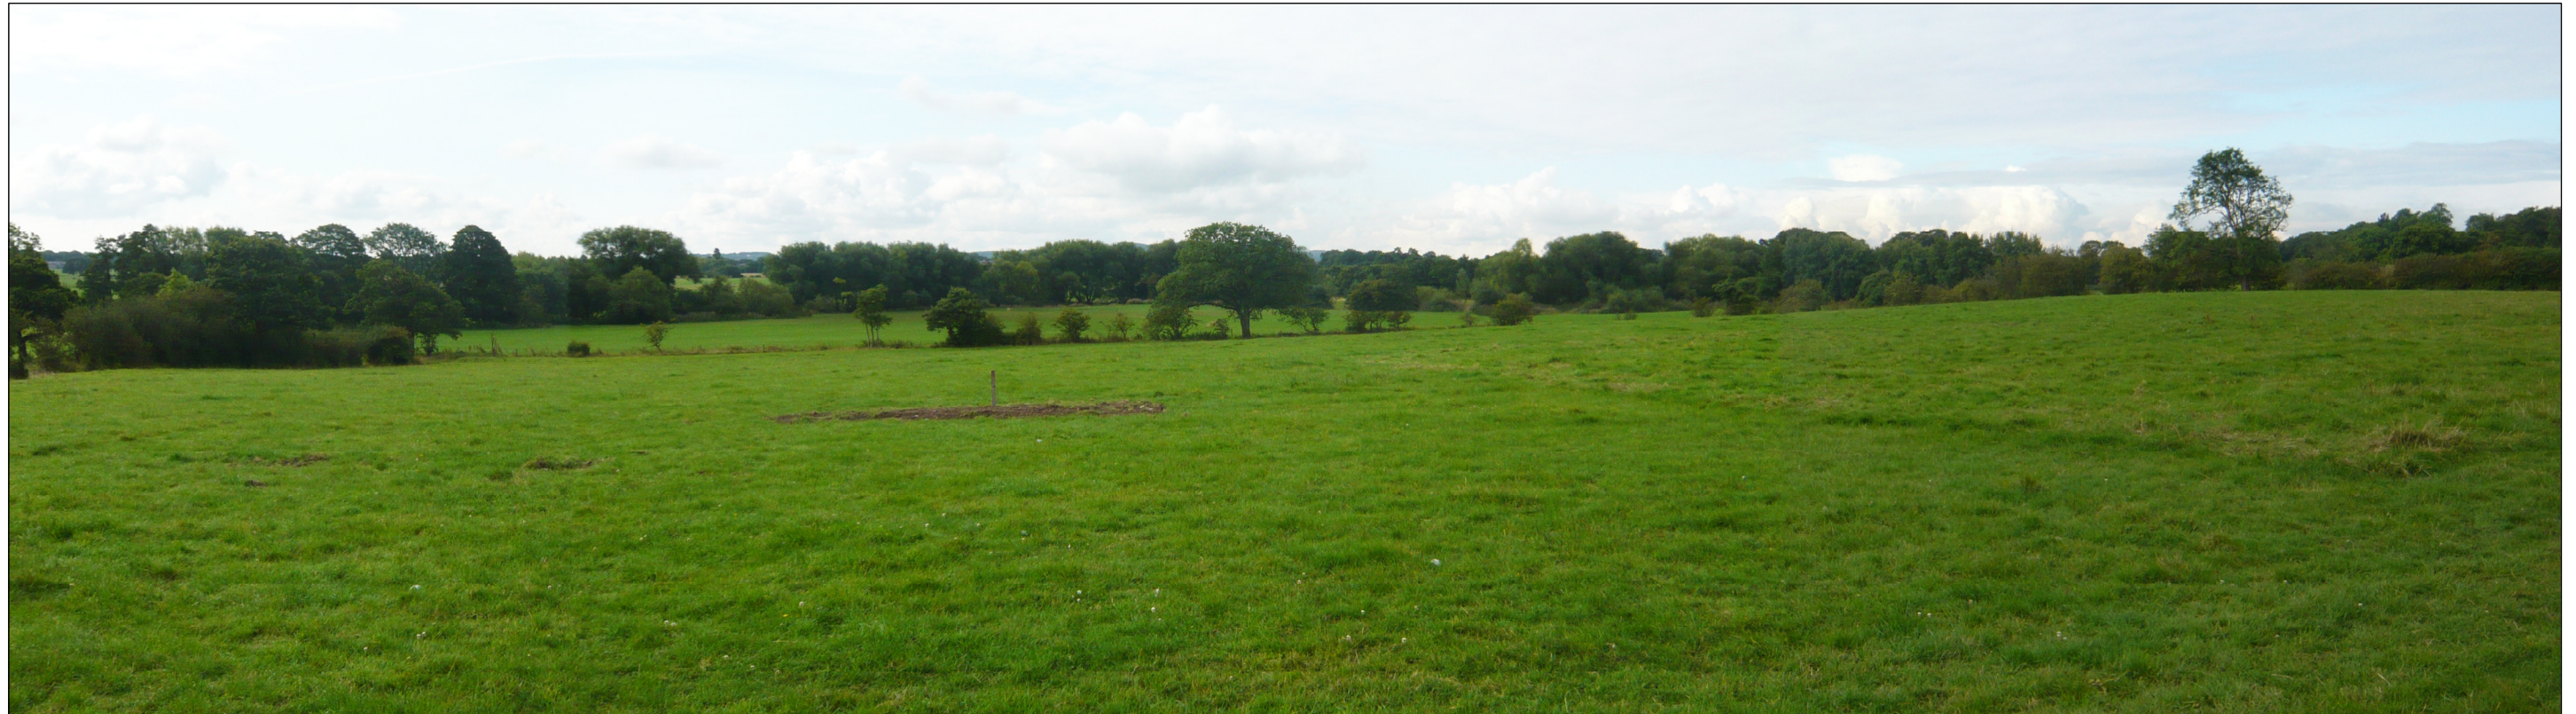
Photoviewpoint D: View south west towards the embankment location from residential property, 'Four Winds'. The property is located on higher ground and residents have panoramic views across open countryside from picture windows and a balcony on the first floor.

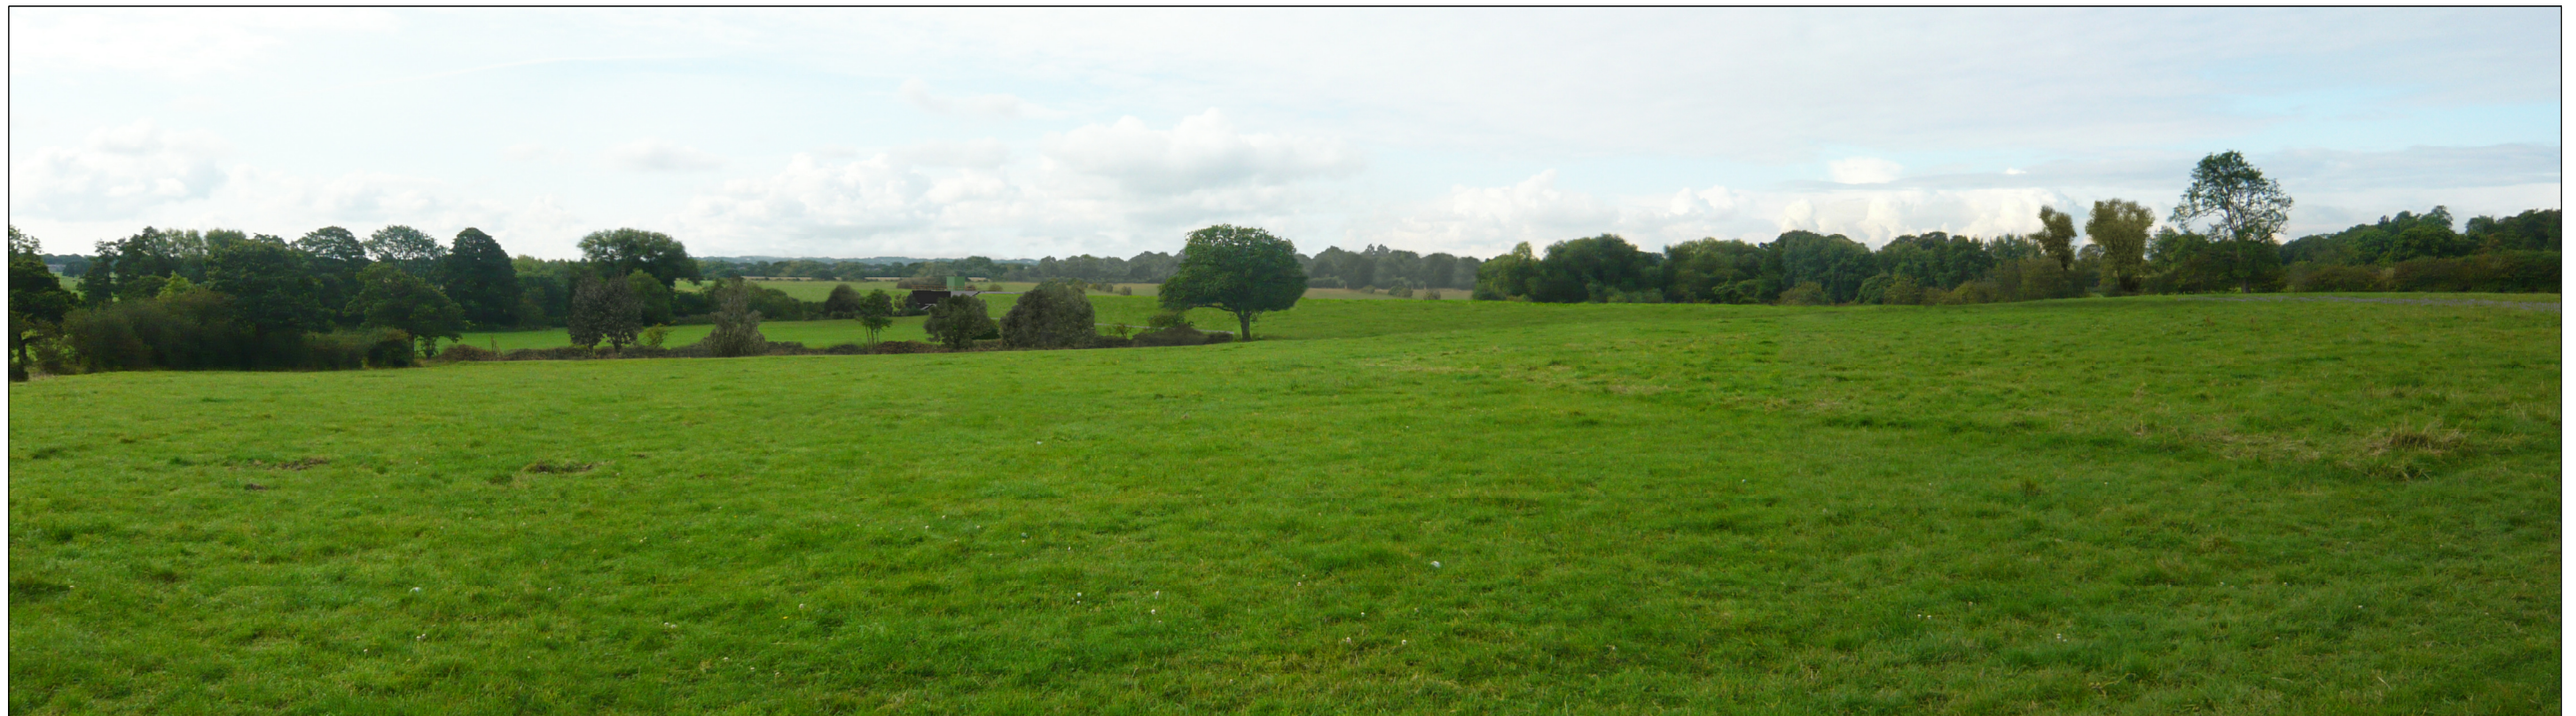
Photomontage D: Residents will notice a shortening of views to the south west. The kiosk and railings will be visible, but new shrub and tree planting will help to filter views once it establishes. The embankment itself will be well integrated from this viewpoint once the grass has established. The change in topography along the ridgeline associated with the northern borrowpit will be just noticeable in first floor views.

3. Photomontage illustrates the view on a summer's day after 15 years with mitigation planting in place.
