CROSTON FRMS DETAILED DESIGN

FIGURE 7.4
SHEET 2
PHOTOMONTAGE B

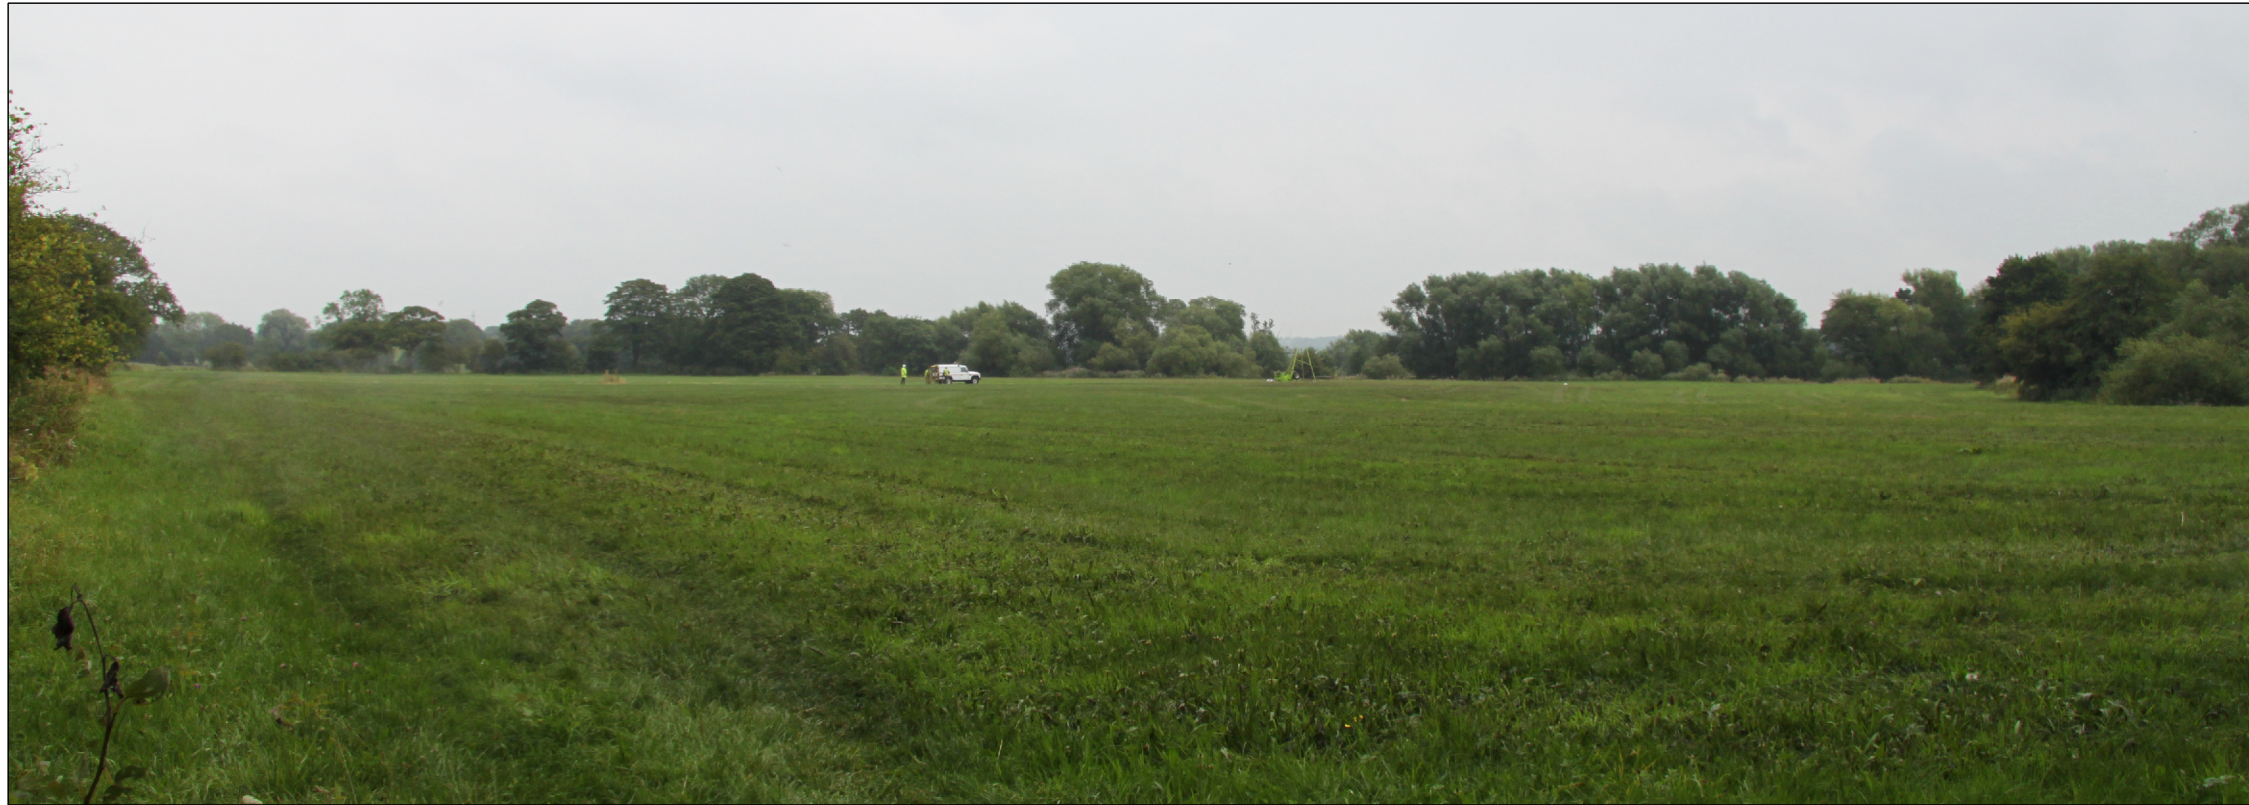
Photoviewpoint B: View east across the northern part of the site from PRow 9-13-FP8.

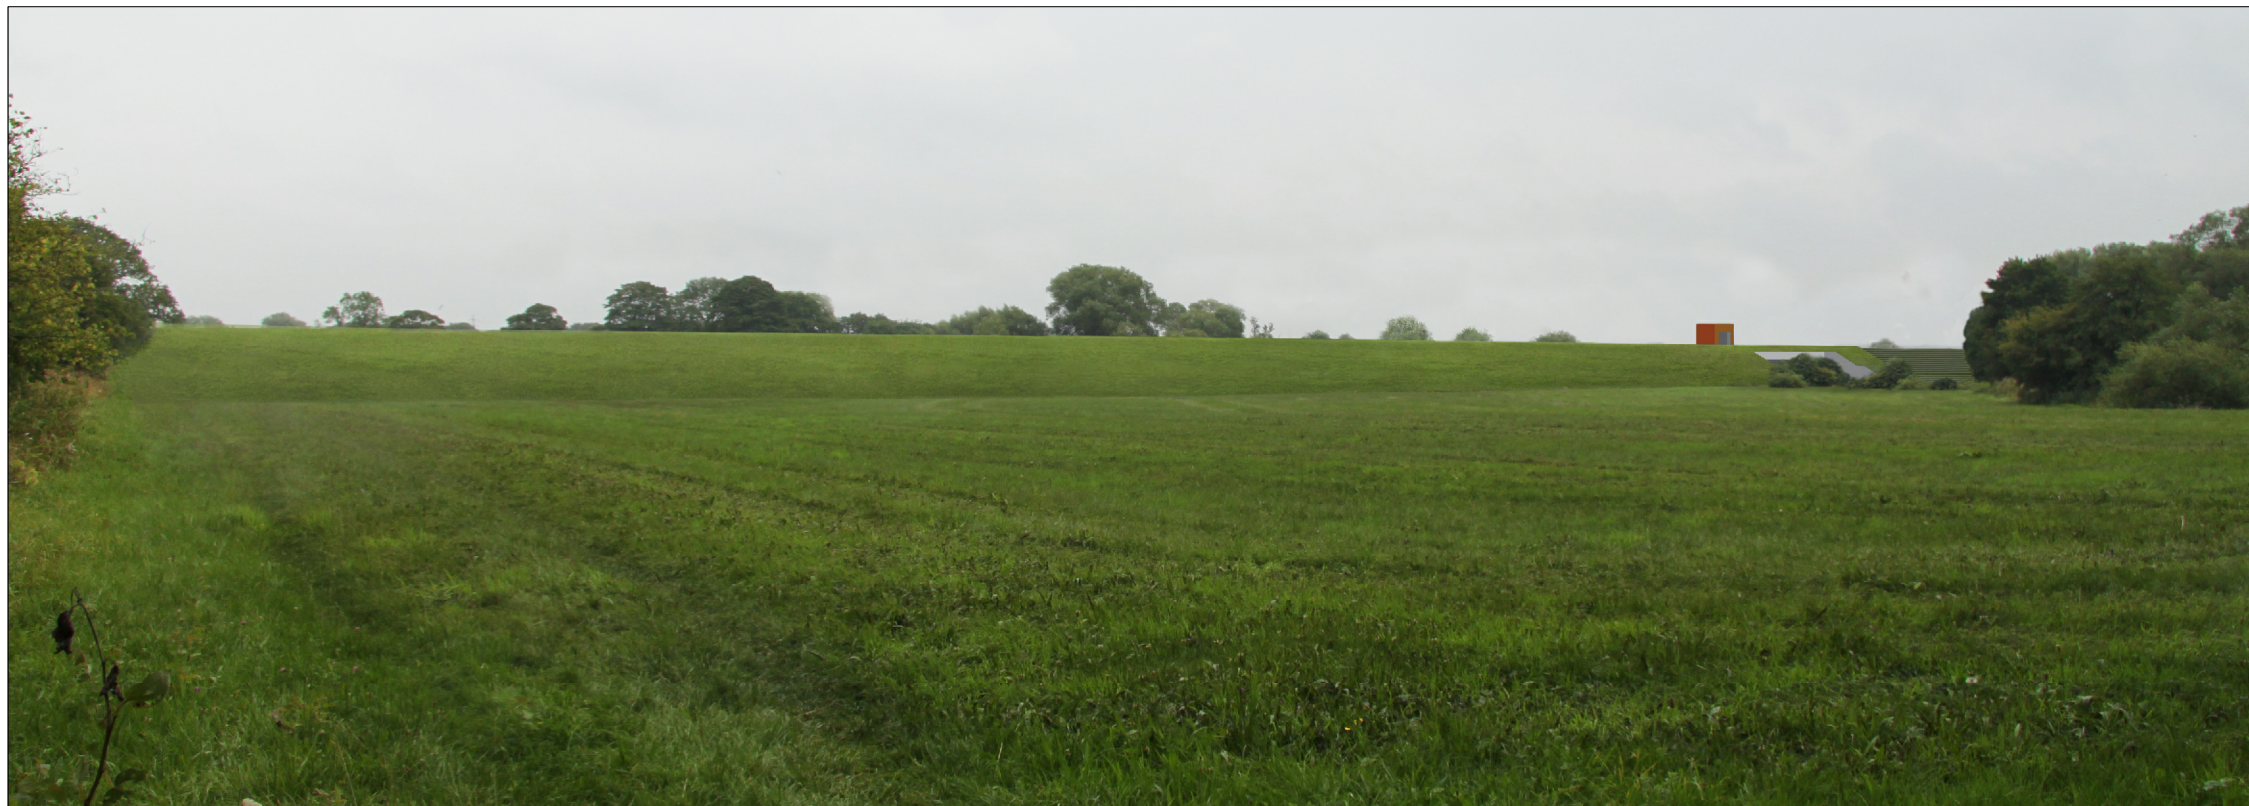
Photomontage B: Looking east along the footpath route, mature vegetation along the river would be removed and the embankment would shorten the view. The top of the kiosk and railings, culvert wing walls and spillway will be visible, but new shrub and tree planting will help to filter views once it establishes.

3. Photomontage illustrates the view on a summer's day after 15 years with mitigation planting in place.
